**Project Name:** Sample Survey  
**Project Description:** CCTV Survey + HPWJ  
**Project Number:** Sample Survey  
**Project Status:** Complete  
**Project Date:** 26/05/2023  
**Inspection Standard:** MSCC5 Sewers & Drainage GB (SRM5 Scoring)

## Section Inspection - 26/05/2023 - SMH16X

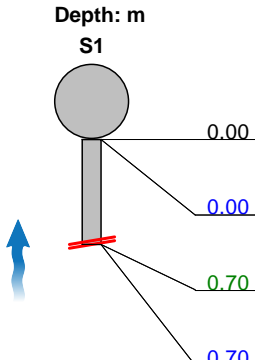
Section	PLR	Grade	Description
6	S1 SPURX	5	Settled deposits, coarse, 100% cross-sectional area loss
11	F1 SPURX	5	Settled deposits, coarse, 100% cross-sectional area loss

0.00	MH	Start node, manhole, reference: S1	00:00:00		
		0.00	WL	Water level, 5% of the vertical dimension	00:00:00		
		0.70	DER	Settled deposits, coarse, 100% cross-sectional area loss	00:00:11		5
		0.70	SA	Survey abandoned: Unable to pass DER, Ready for future connection	00:00:13

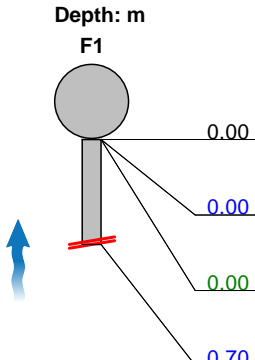
0.00	MH	Start node, manhole, reference: F1	00:00:00		
		0.00	WL	Water level, 5% of the vertical dimension	00:00:01		
		0.00	DER	Settled deposits, coarse, 100% cross-sectional area loss	00:00:01		5
		0.70	SA	Survey abandoned: Unable to pass DER, Ready for future connection	00:00:10
